WORKSHOP *fib* MC2020 –São Paulo, Brazil, 2017

# A CASE STUDY: The 27F Chilean EQ

February 27th, 2010 – Chile

# 27F CHILEAN EQ

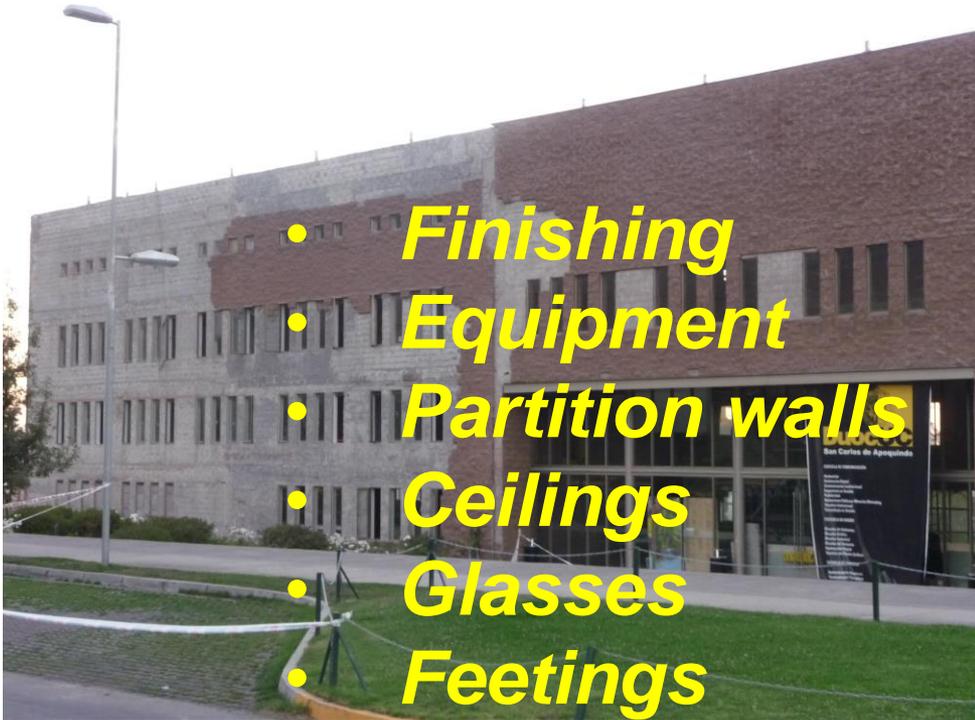
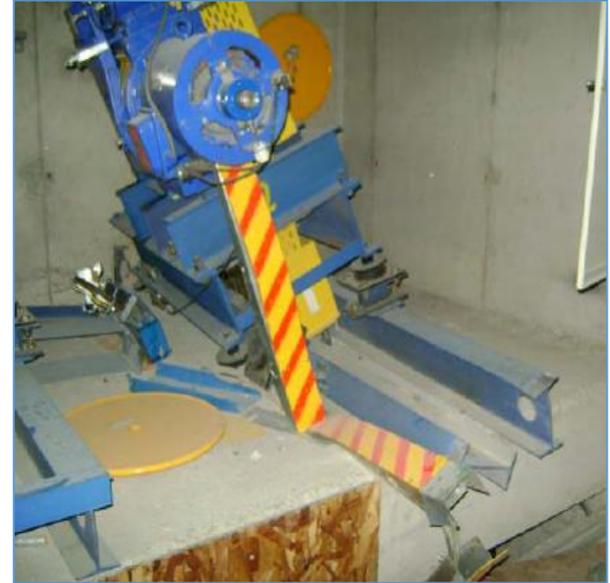
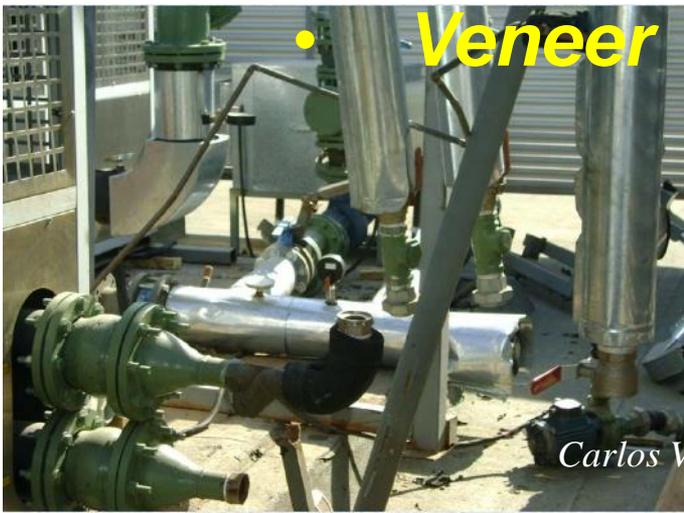
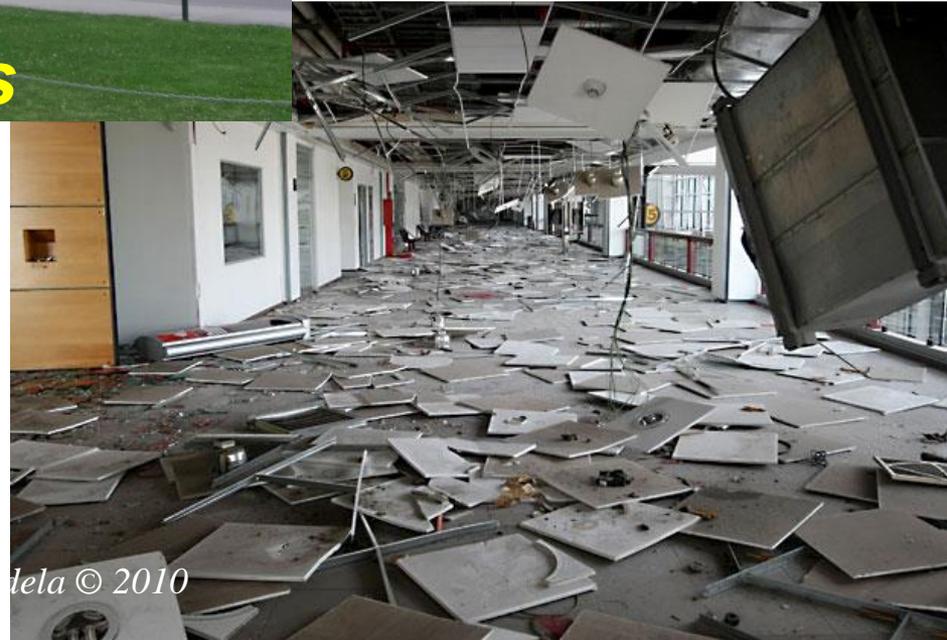
# ➤ Failure of Non Structural Members

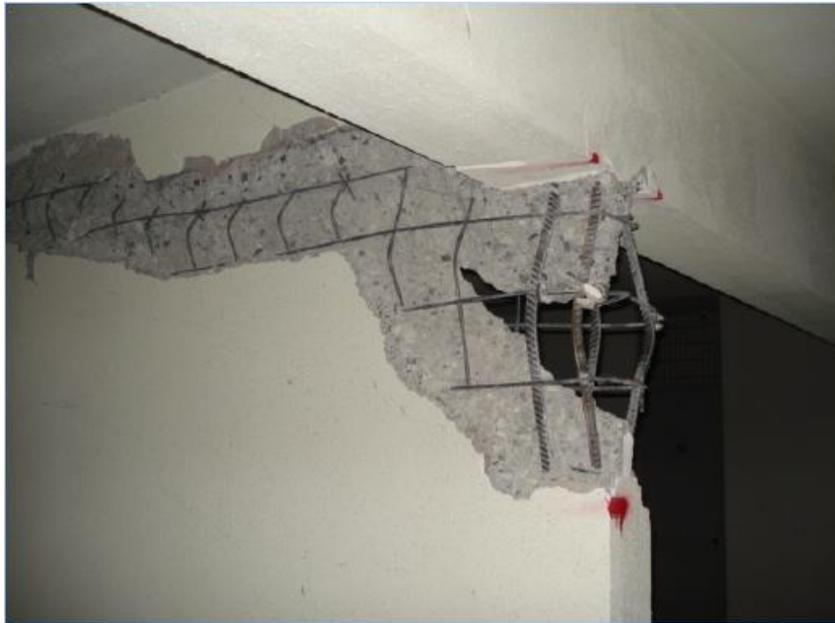
**Failure without compression  
for no evidence of cover  
cracking (R. Saragoni)**

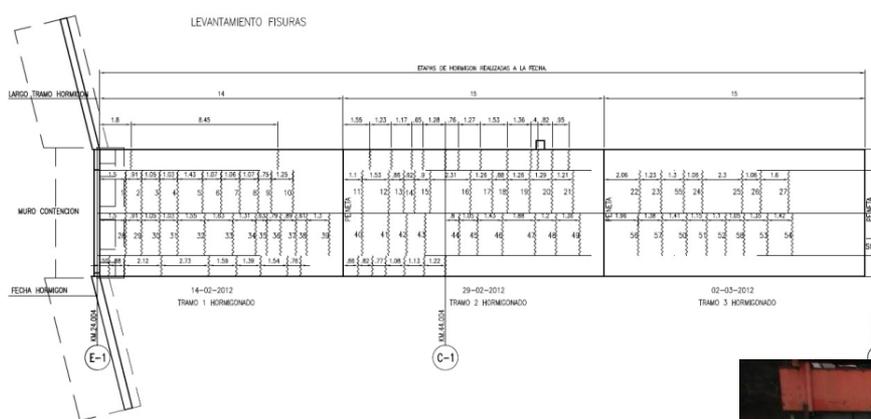
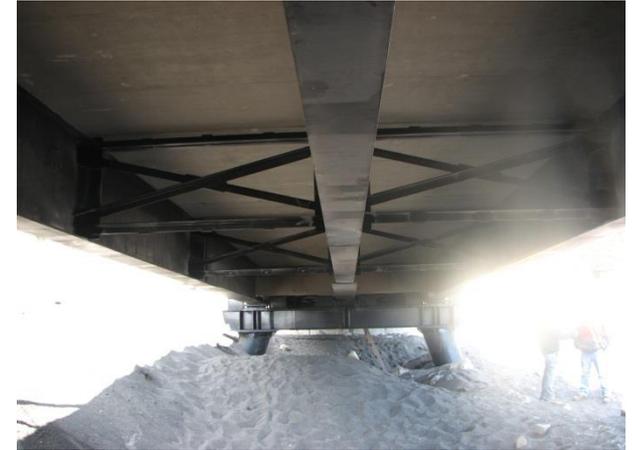
Figura 4-6: levantamiento de fisuras / grietas en obra.

**Excessive cracking due to construction sequence**

**Structural Engineers do not usually consider the construction process at the design stage**

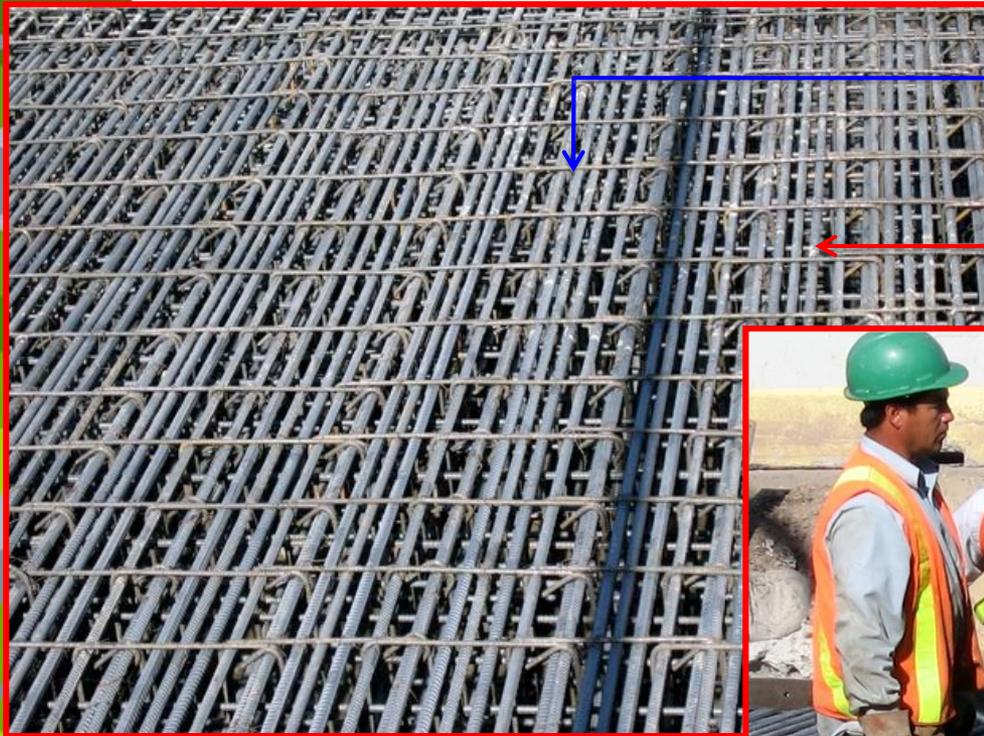
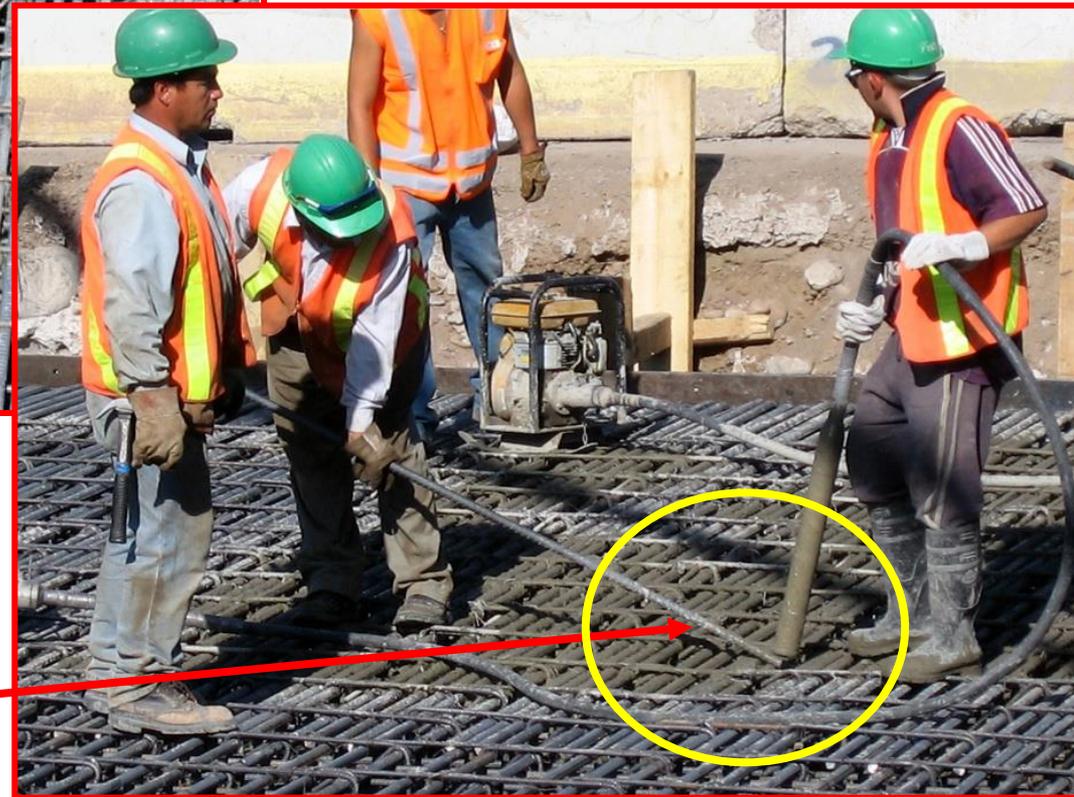
1.0 m. height  
R.C. Slab  
V&A, 2008

Moving reinforcing  
bars with a bar to  
vibrate concrete

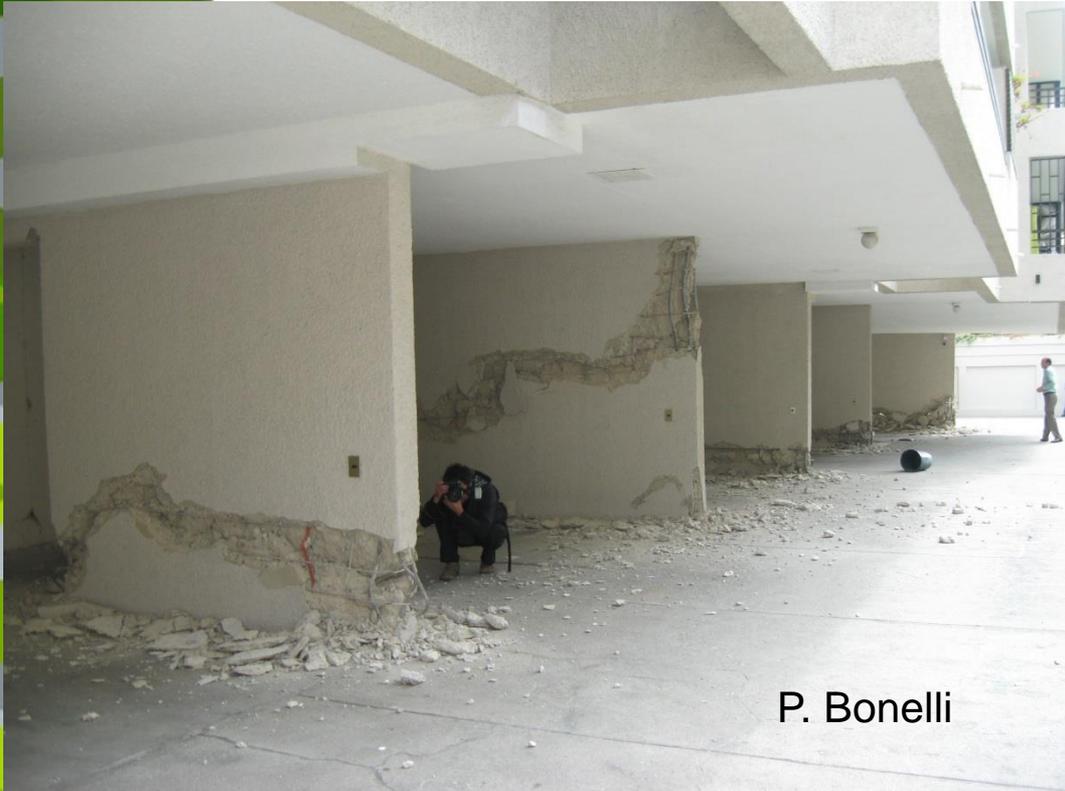
**Edificio Toledo, Viña**

➤ *Walls too slender  
(thickness 20 cm)*

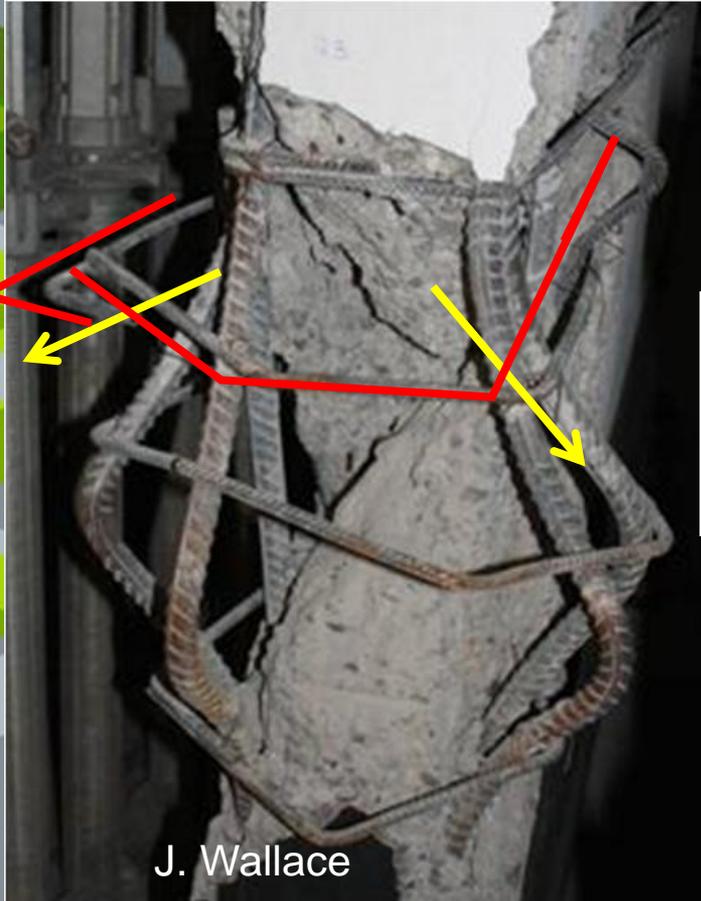
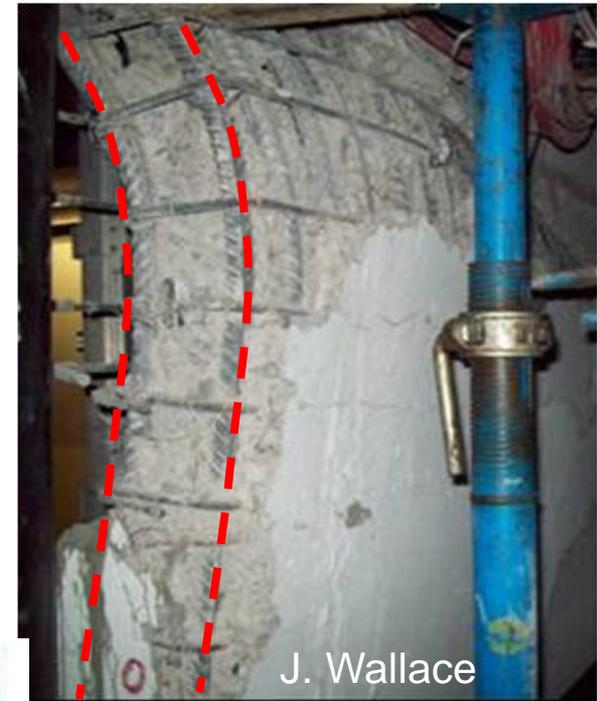
# ➤ Overall buckling – thin walls

concrete crushing and rebar buckling & fracture

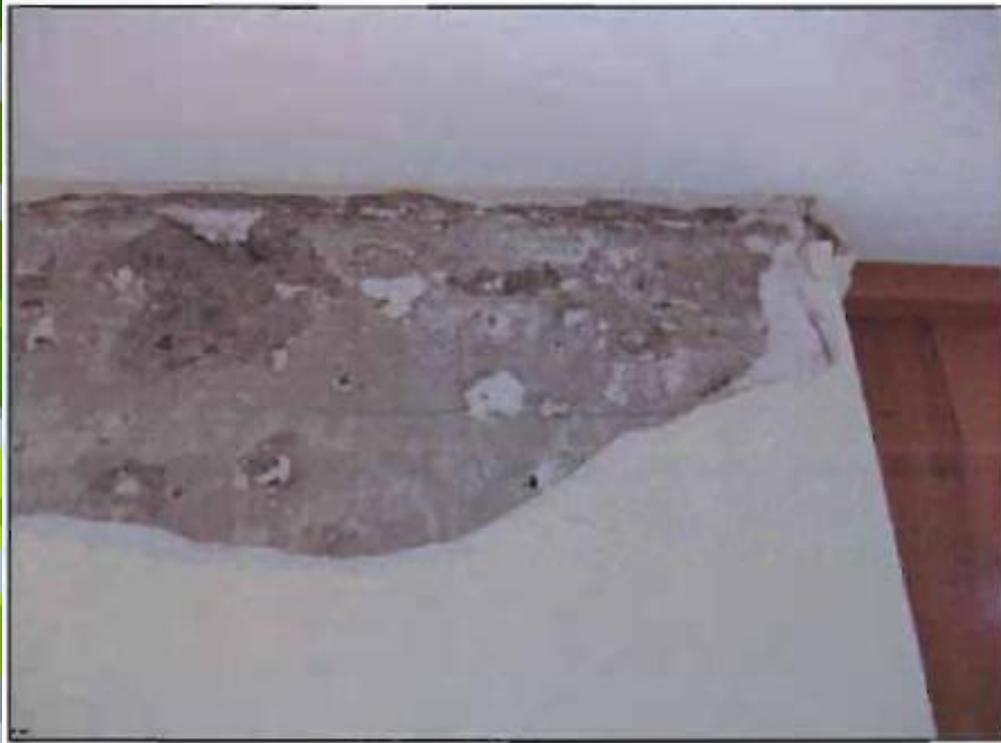
**Edificio El Parque**

➤ *Very heavy loaded walls*

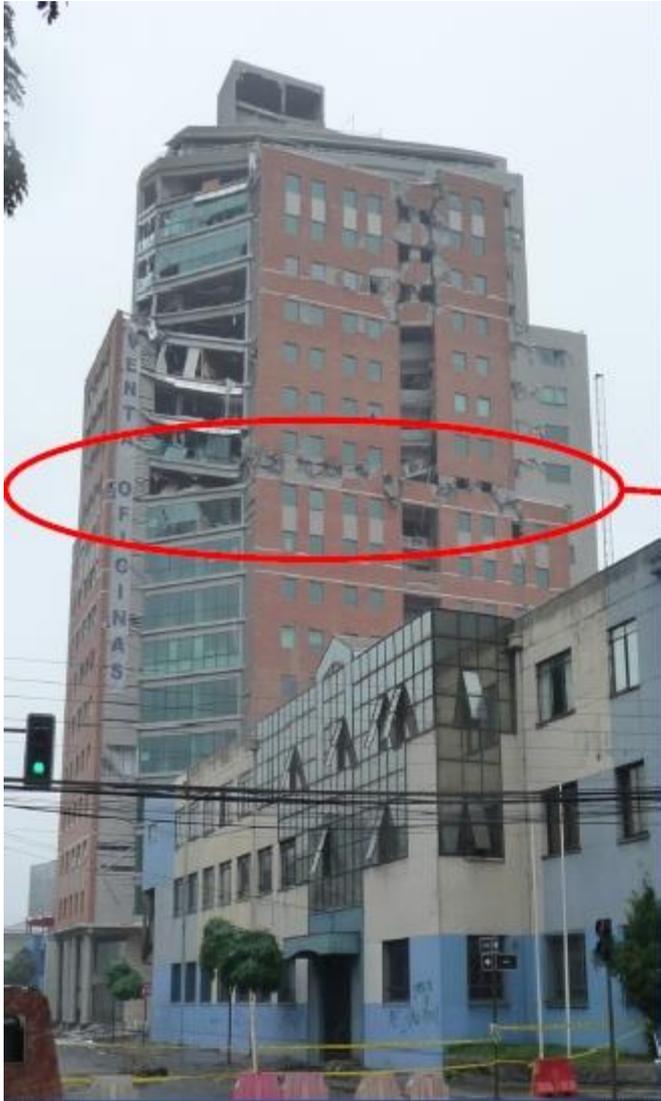
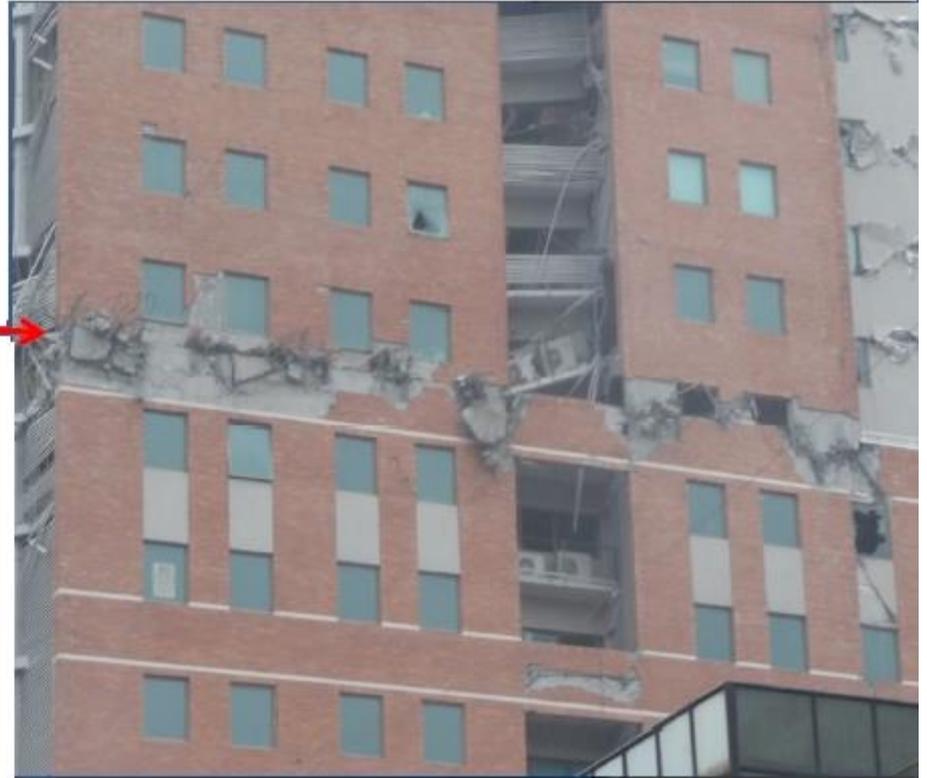
Concepcion

## ➤ *Soft floor*

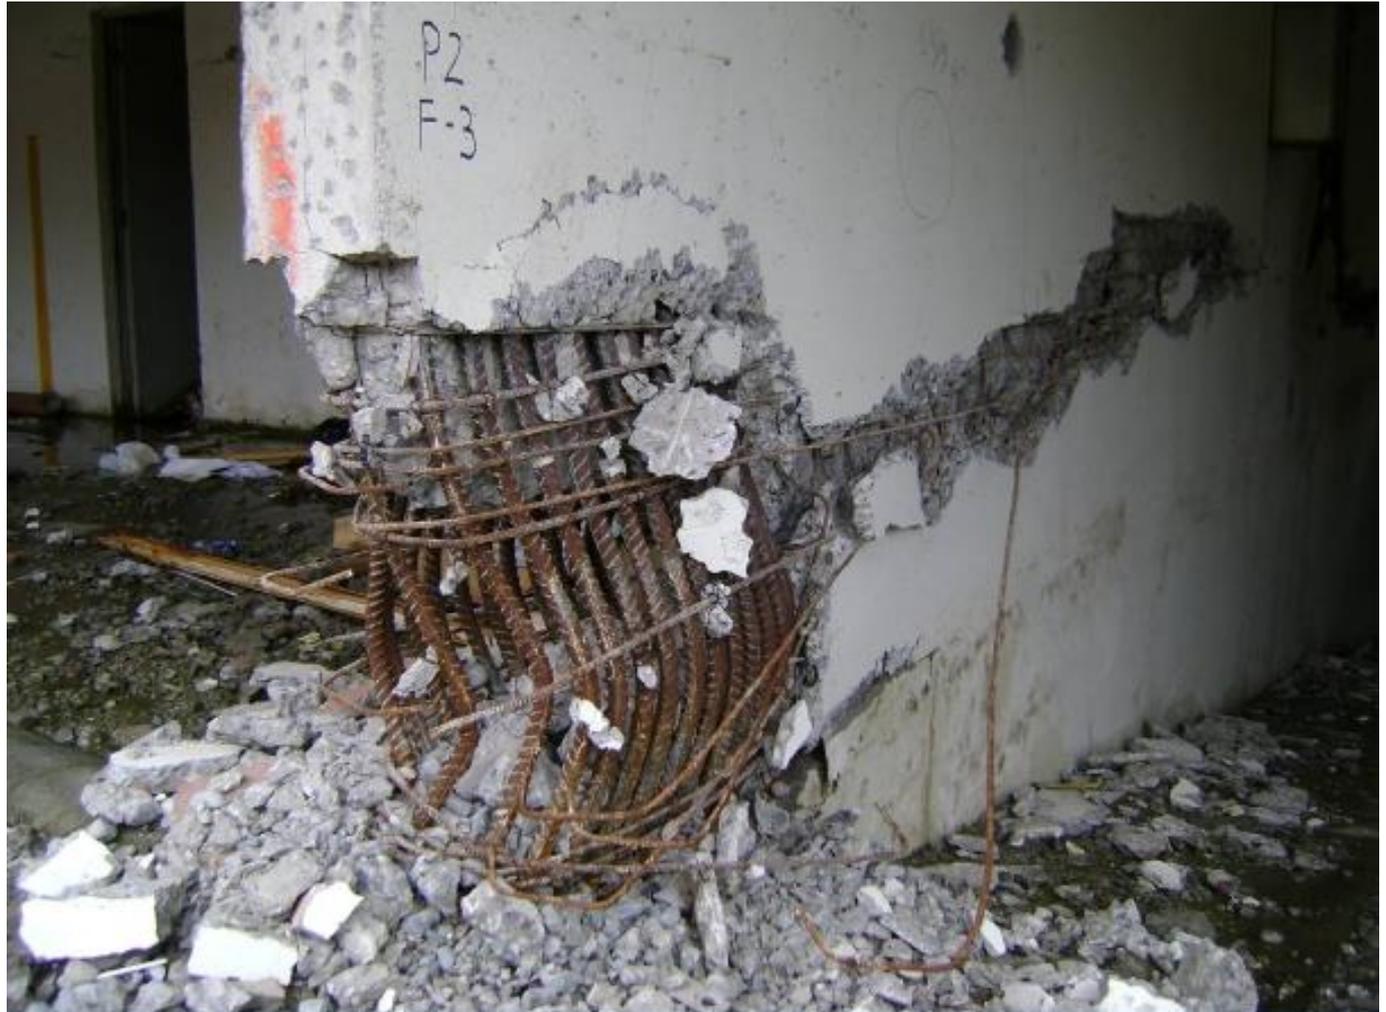
➤ *Lack of concrete confinement*

**Agglomeration of thick bars without confinement**

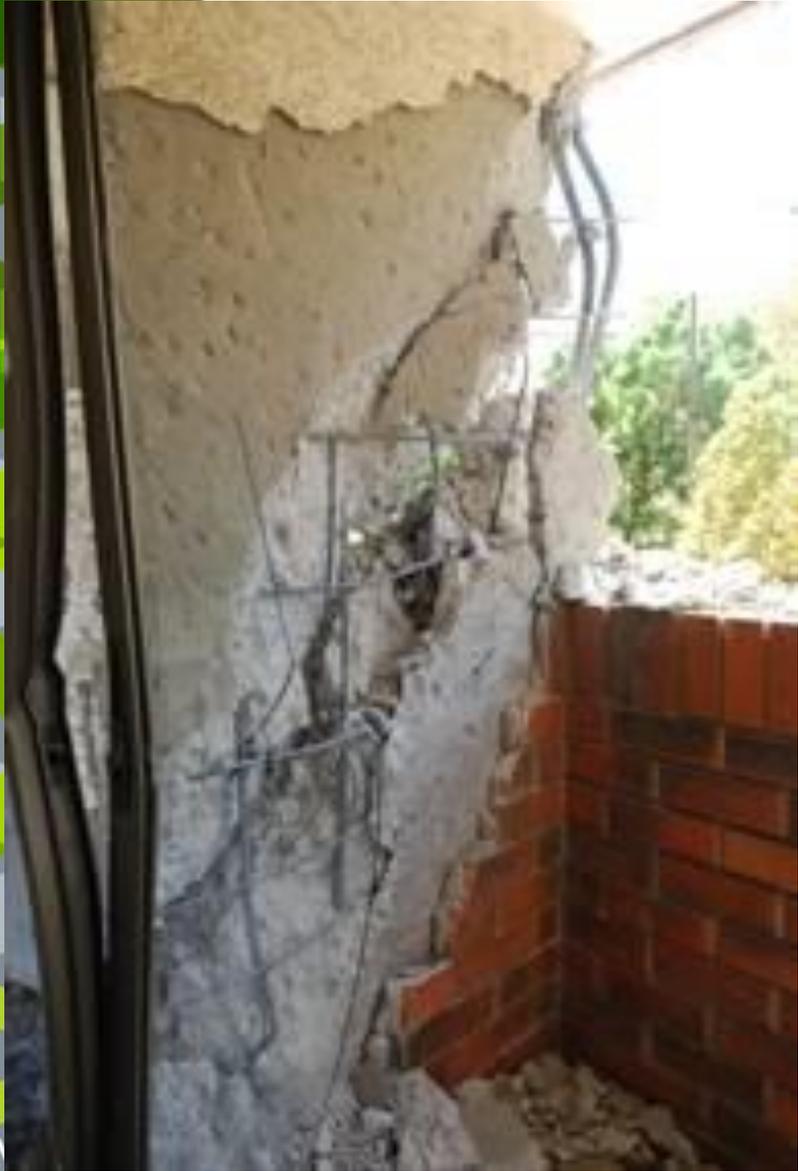
**Edificio Central Park**

➤ *Few shear failures*

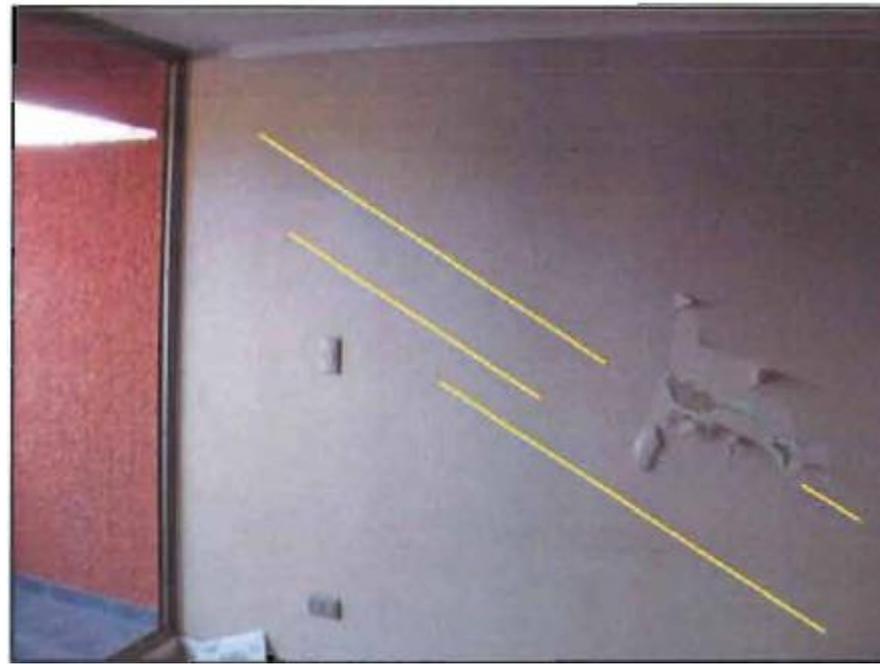
**Edificio El Parque (fisura corte 0,5 mm)**

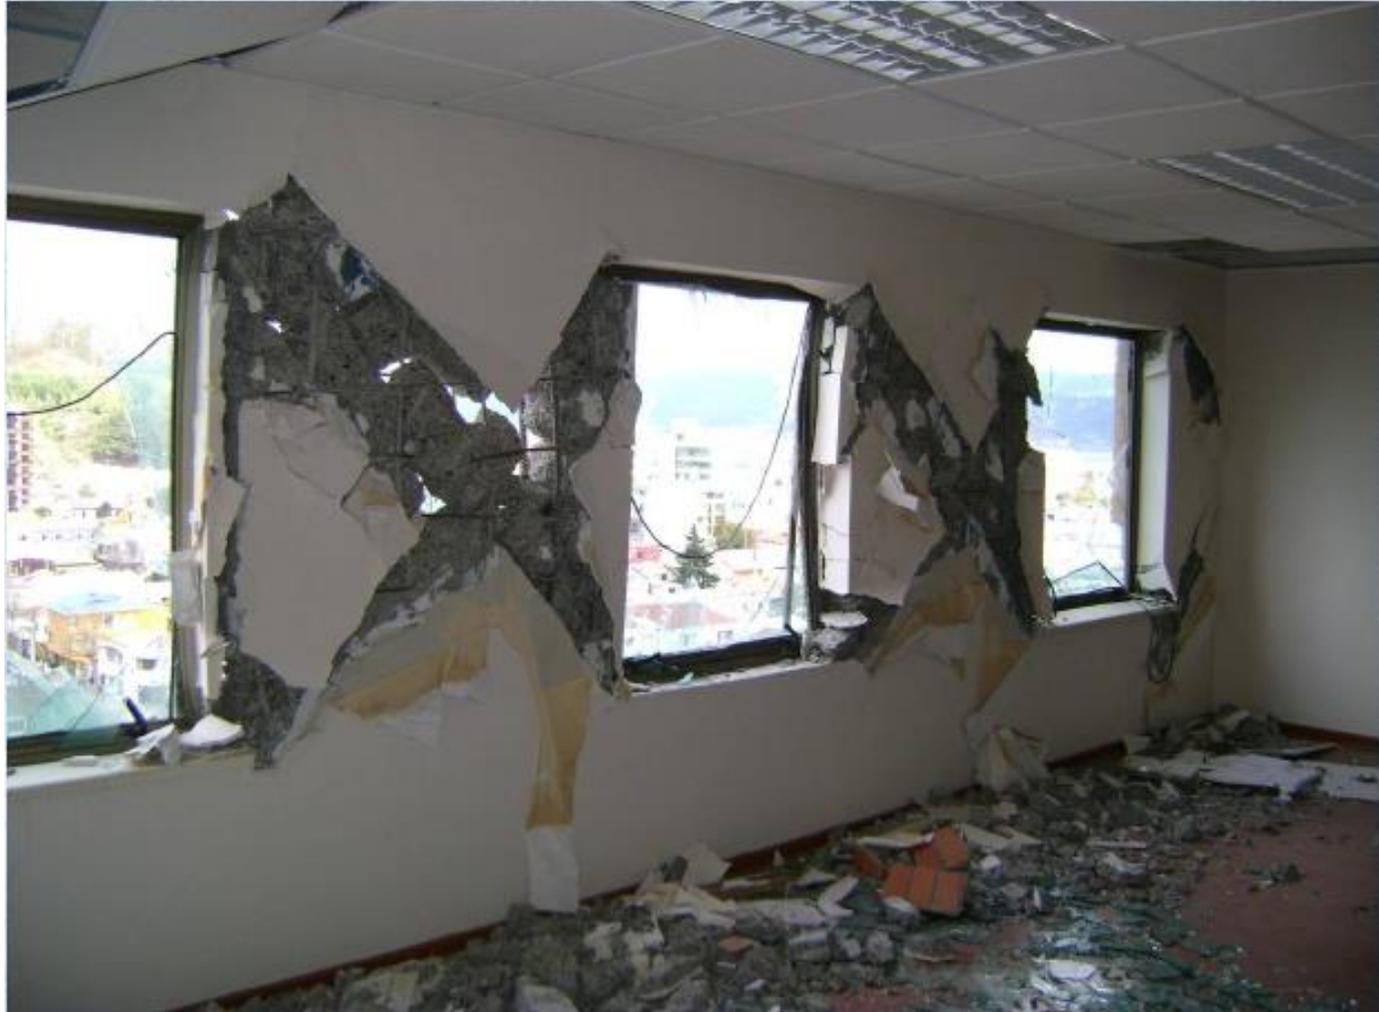
➤ *Shear failures in short columns  
(traditional failure)*

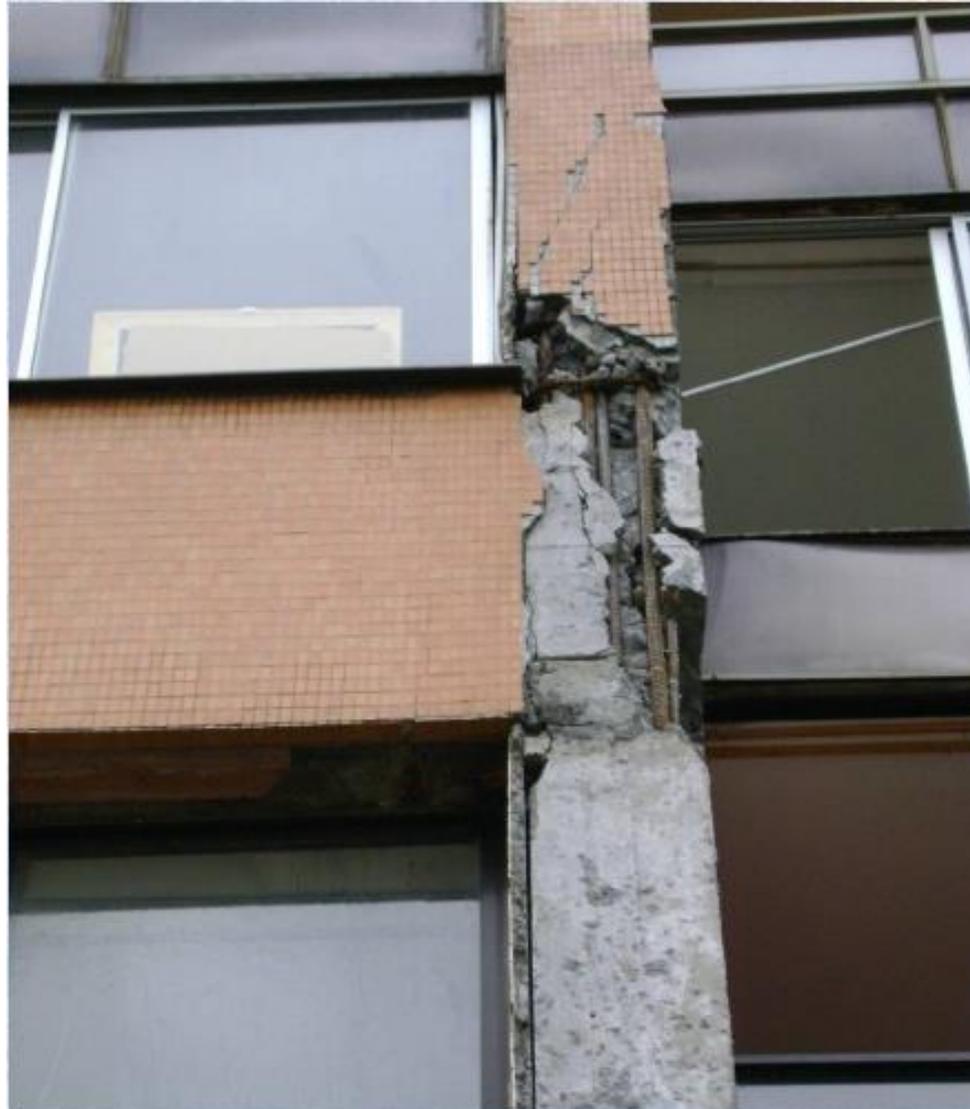
➤ *Reinforcement detailing:  
Absence of confinement in joints*

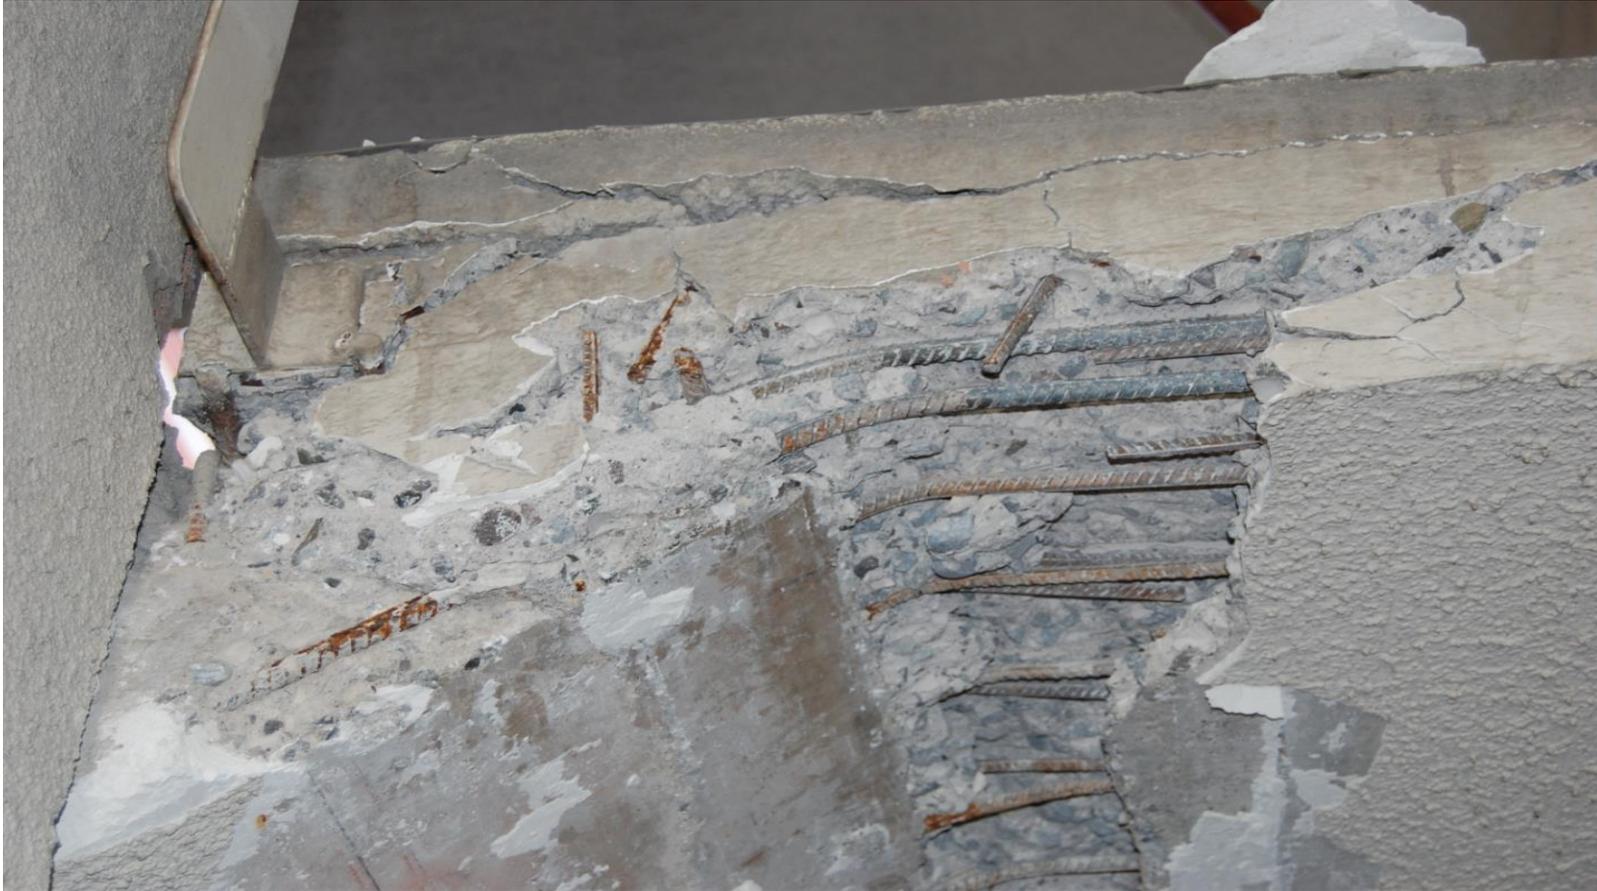
➤ Reinforcement detailing:  
*Misinterpretation of the drawings*

- **Different to drawings**

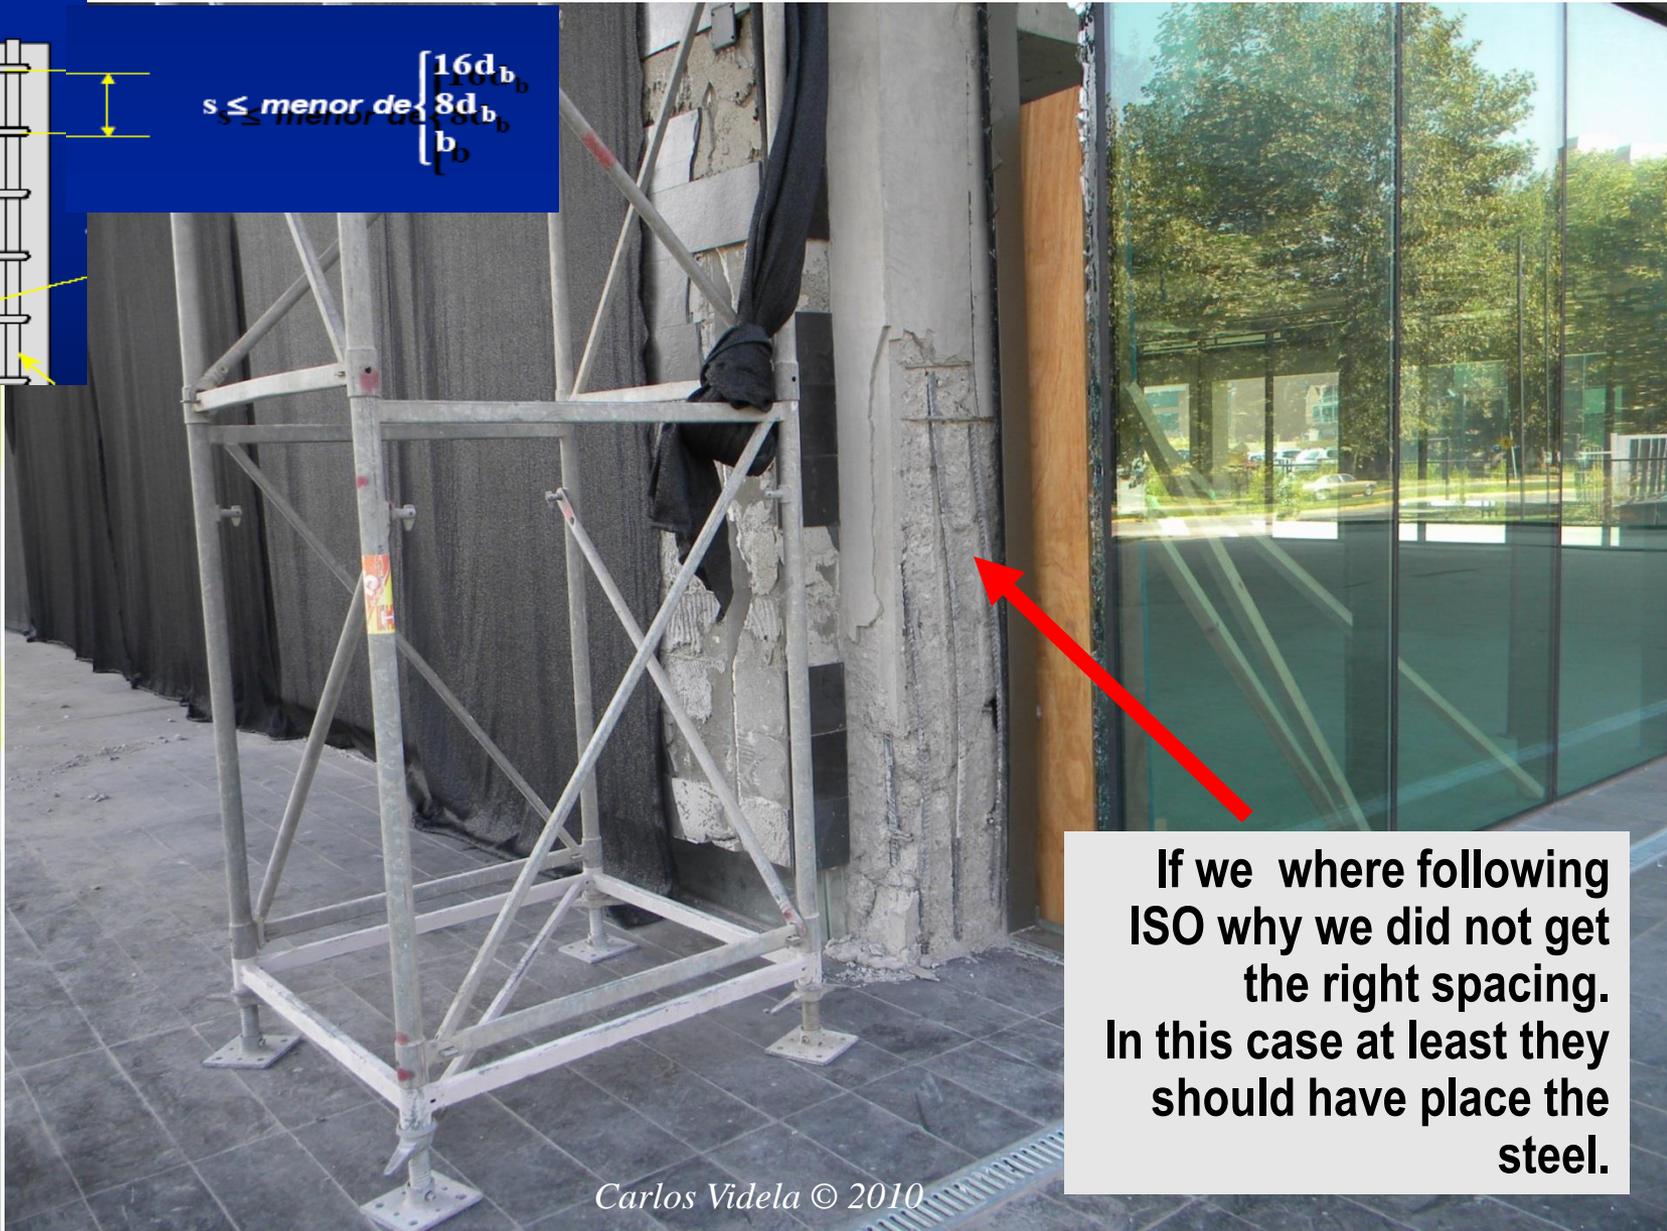
# ➤ Reinforcement detailing: Stirrups

**If we were following ISO why we did not get the right spacing. In this case at least they should have placed the steel.**

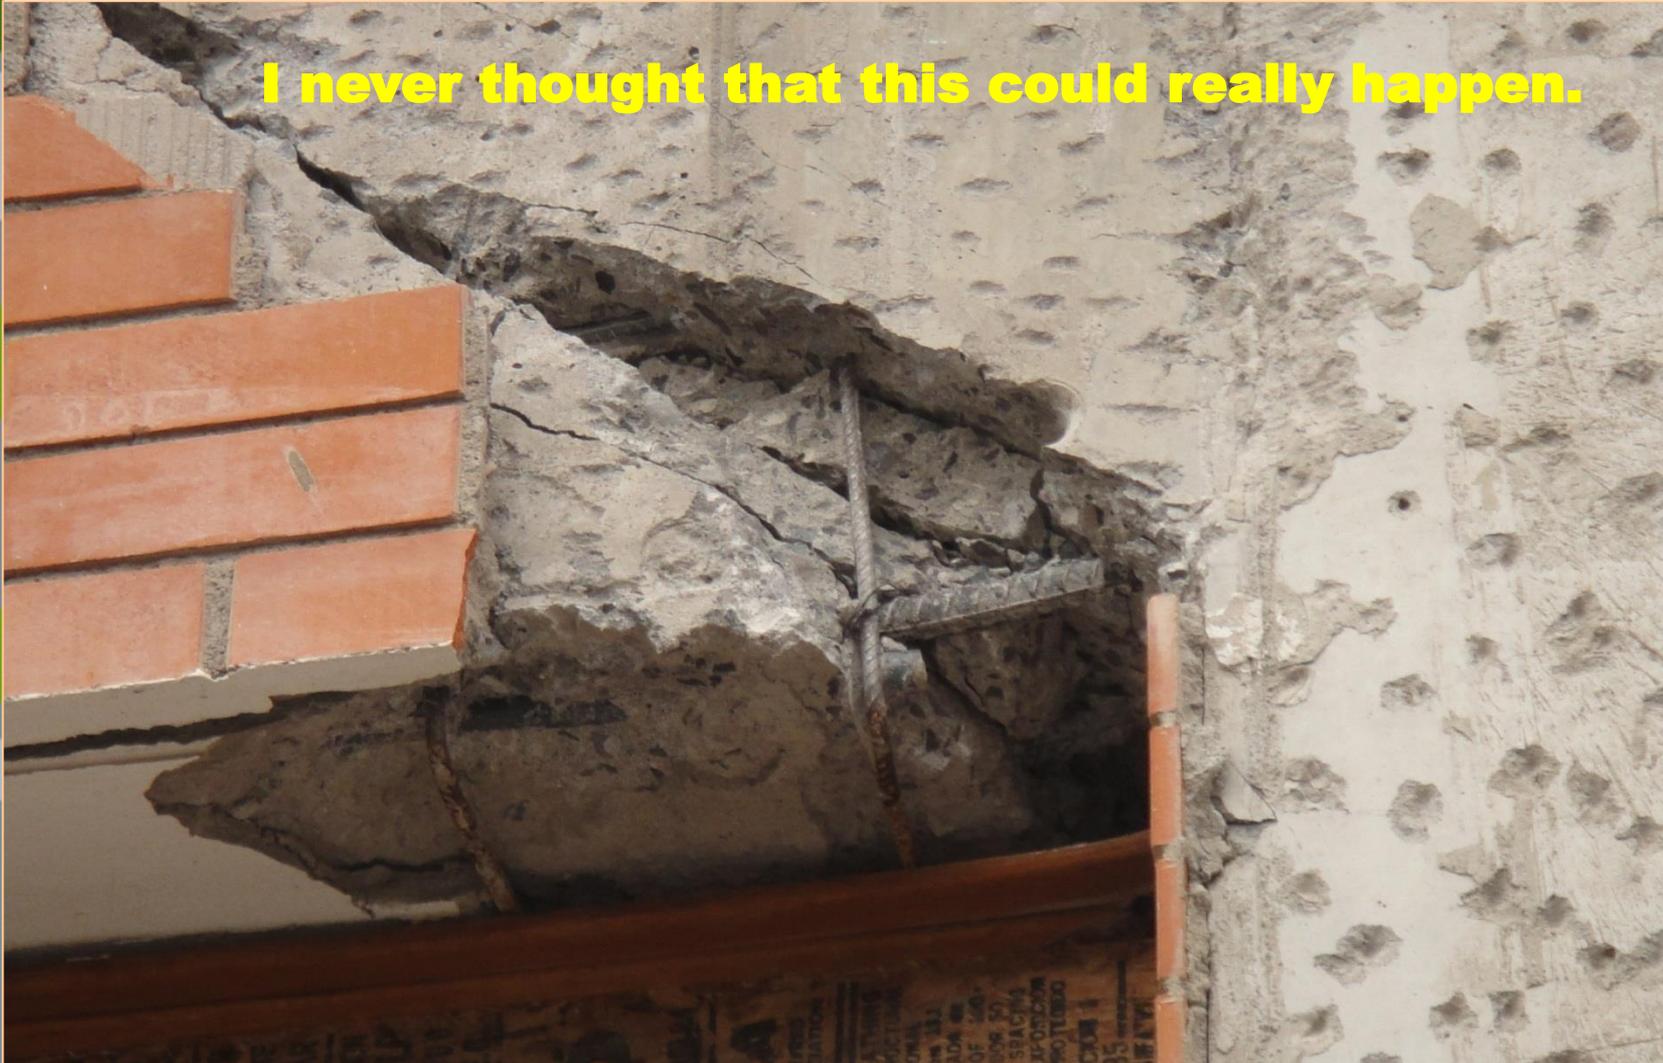
➤ Reinforcement detailing:  
*No anchorage*

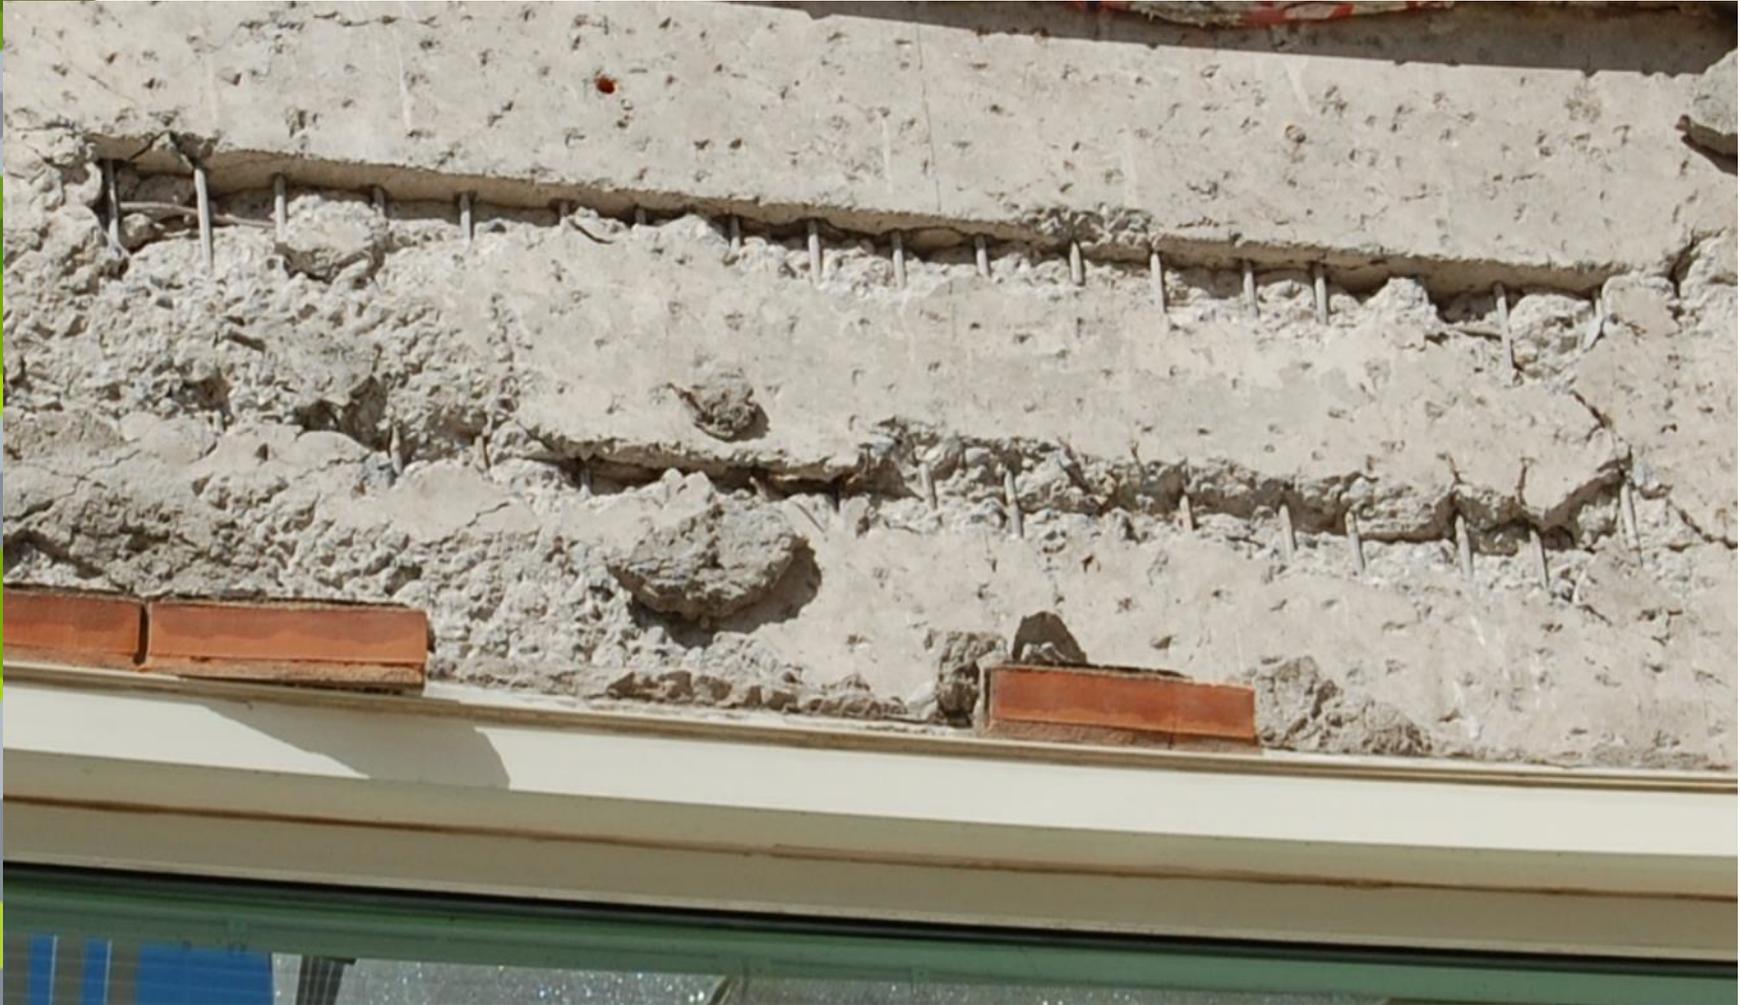
## ➤ *Bad construction joints*

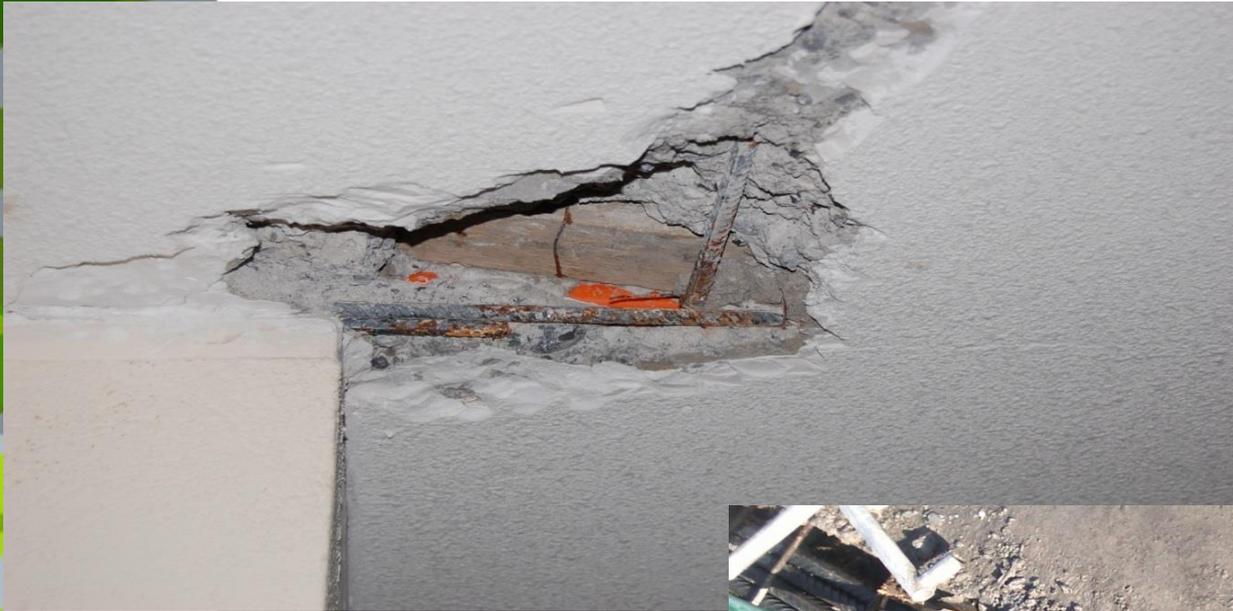
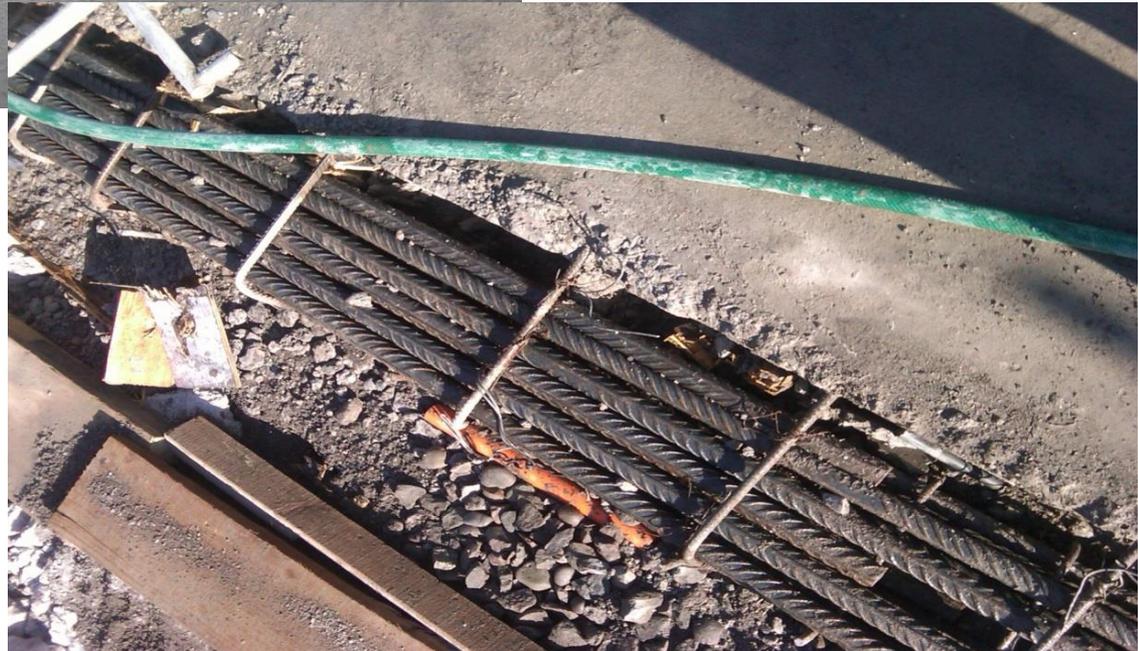
## ➤ Lack of concrete continuity
