WORKSHOP *fib* MC2020 –São Paulo, Brazil, 2017

# A CASE STUDY: The 27F Chilean EQ

February 27th, 2010 – Chile

# 27F CHILEAN EQ

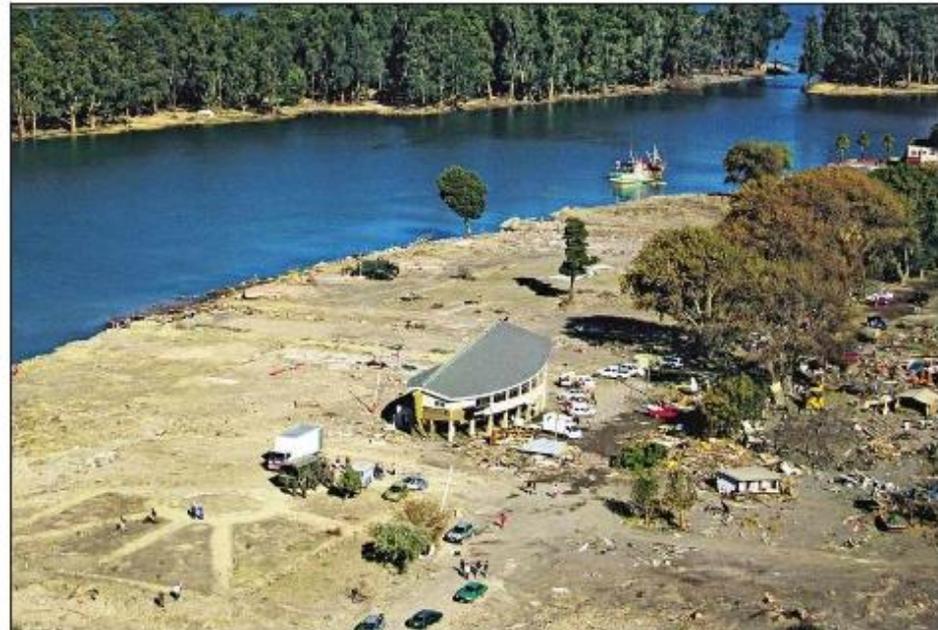
Después de la destrucción causada por las olas del maremoto sólo se mantuvo en pie parte de la Casa de Botes, un moderno recinto municipal equipado con instalaciones para los cultores del canotaje. **C 12**

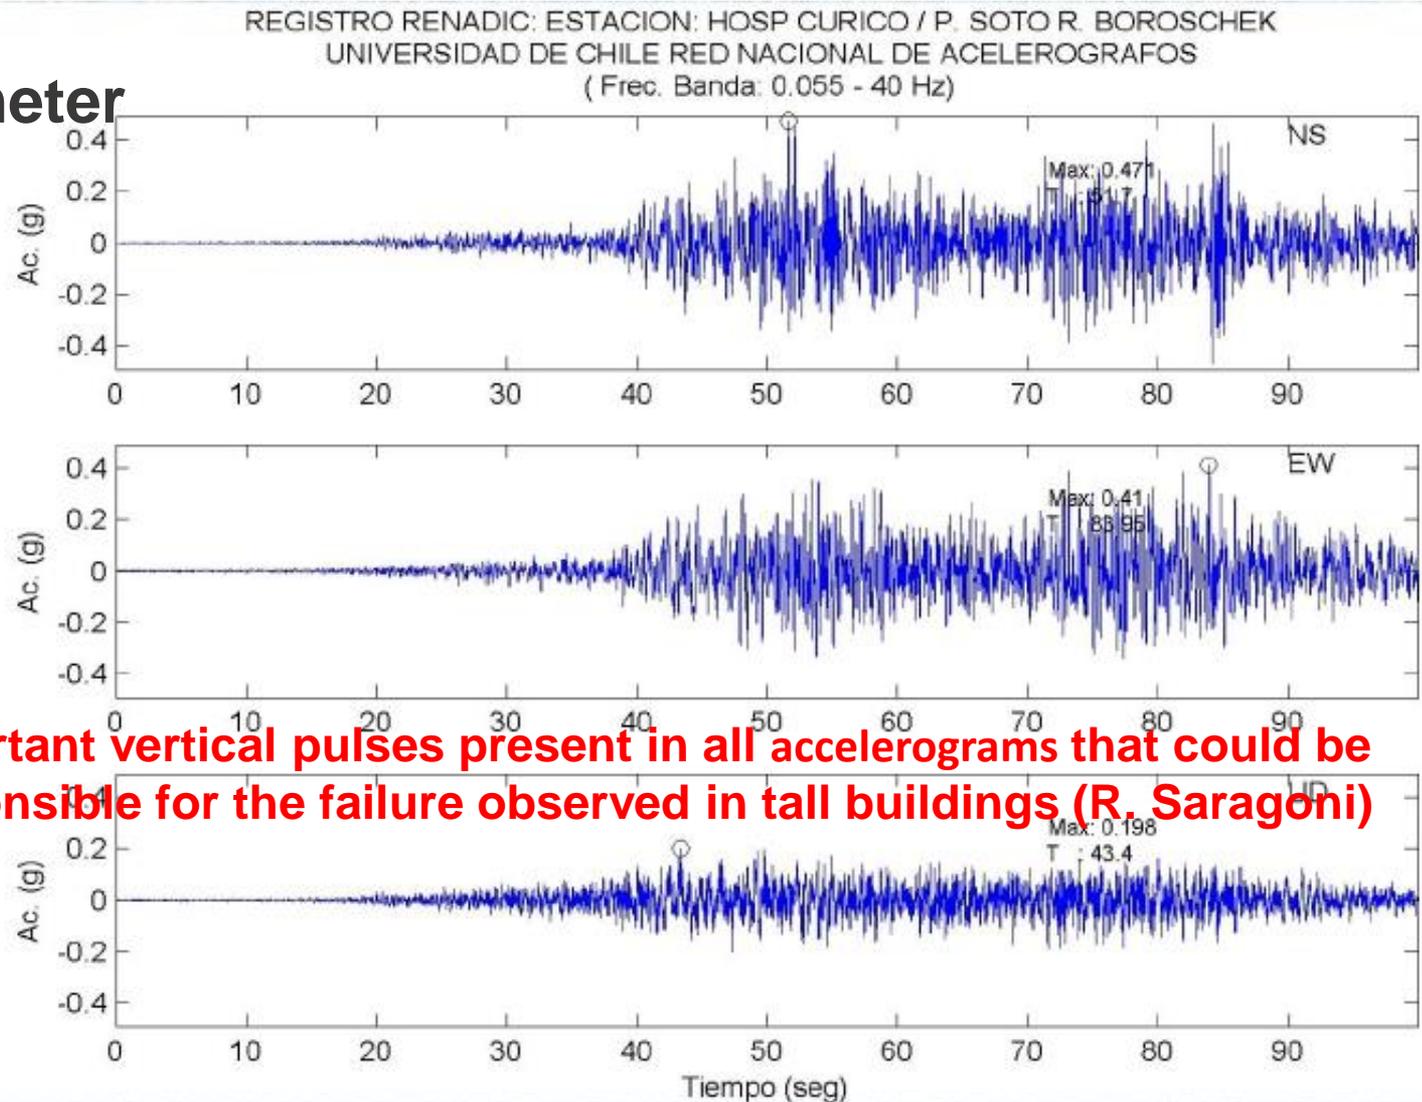
**Important vertical pulses present in all accelerograms that could be responsible for the failure observed in tall buildings (R. Saragoni)**

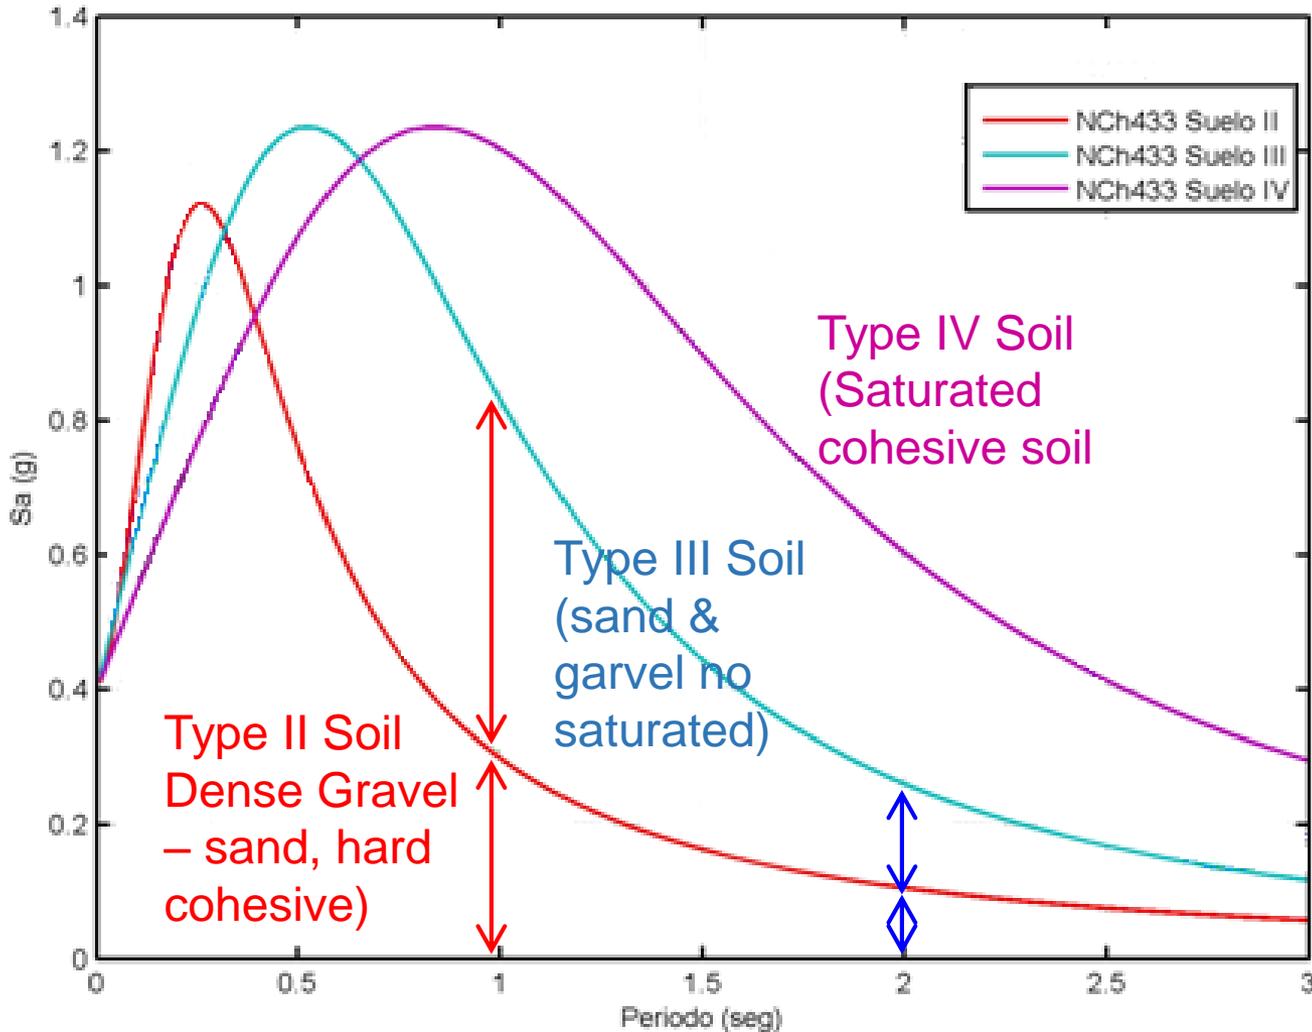
Response Spectrum: Seismic Zone 3

- Spectra obtained from records in Santiago for Type II soil gave **displacements between 50% and 120% higher than the NCh433. of 96 standard**
